**CITY OF MIAMI
PLANNING DEPARTMENT**

Staff Report & Recommendation

Subject: **Item No. 4 – 1015 NW 10 Court**

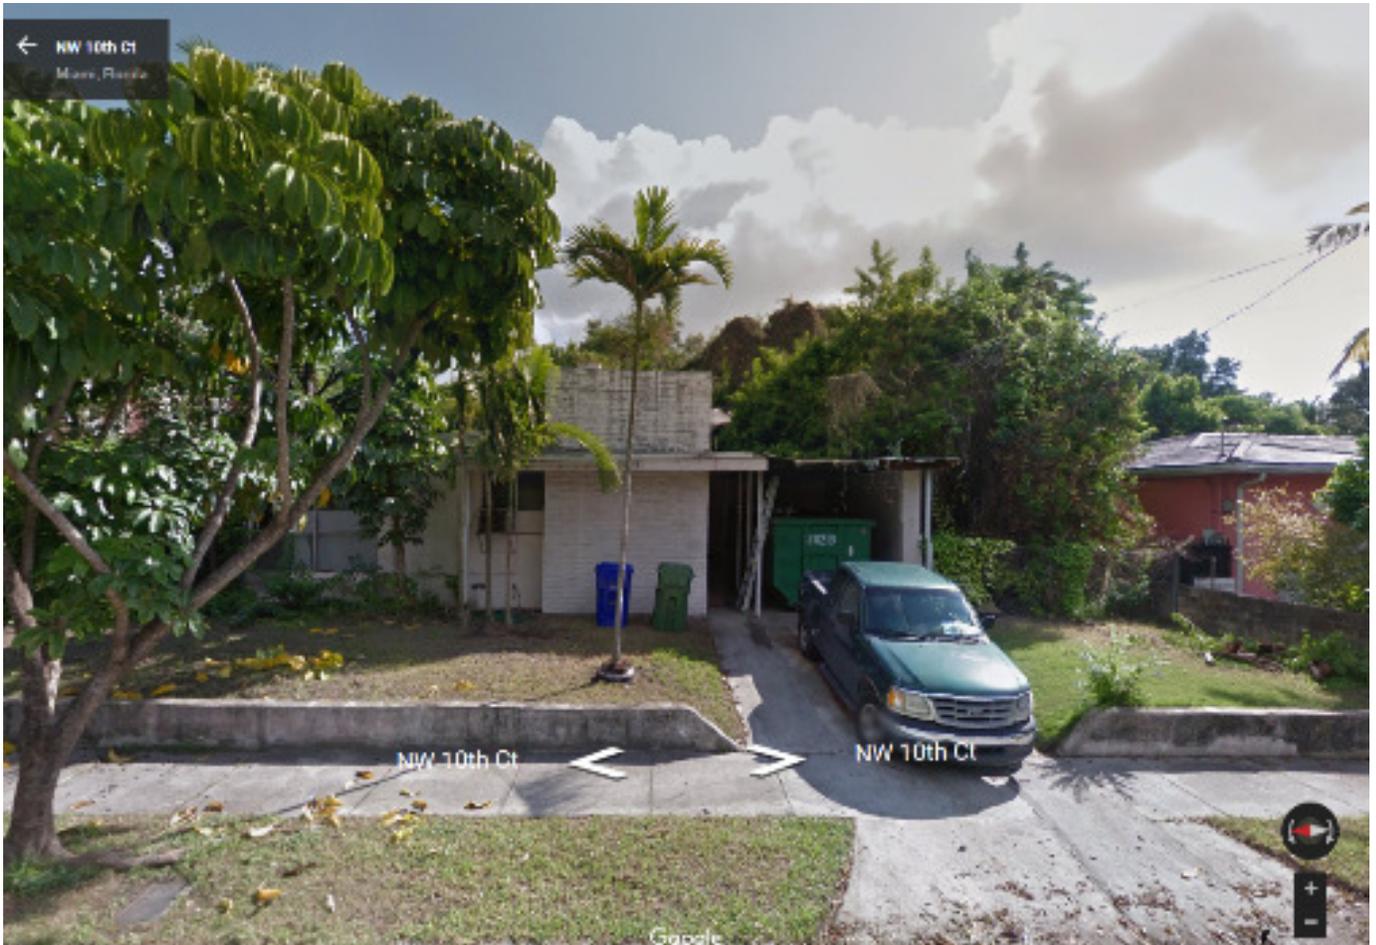
CURRENT PHOTO:

The applicant is proposing to demolish the existing building and to construct a new single family residence. The existing structure appears to be in an advanced state of deterioration, however it is not currently on the City's Unsafe Structures list.

The Preservation Office is once again faced with the difficult task of making a recommendation regarding the proposed demolition of a building within a historic district. This particular property is identified as contributing, and appears to be in a serious state of disrepair. Recent photographs provided by the applicant show extensive roofing and wall material to be missing, thus leaving the structure significantly open to the elements.

The Preservation Office recommends, in accordance with the Secretary of the Interior Standards for Historic Preservation, that the application for the demolition of a contributing structure and the new construction of a single family residence be **Continued**.
